AUGUST 27, 2015

VILLAGE FIRE DEPARTMENT FIRE STATION No. 1

FEASIBILITY STUDY

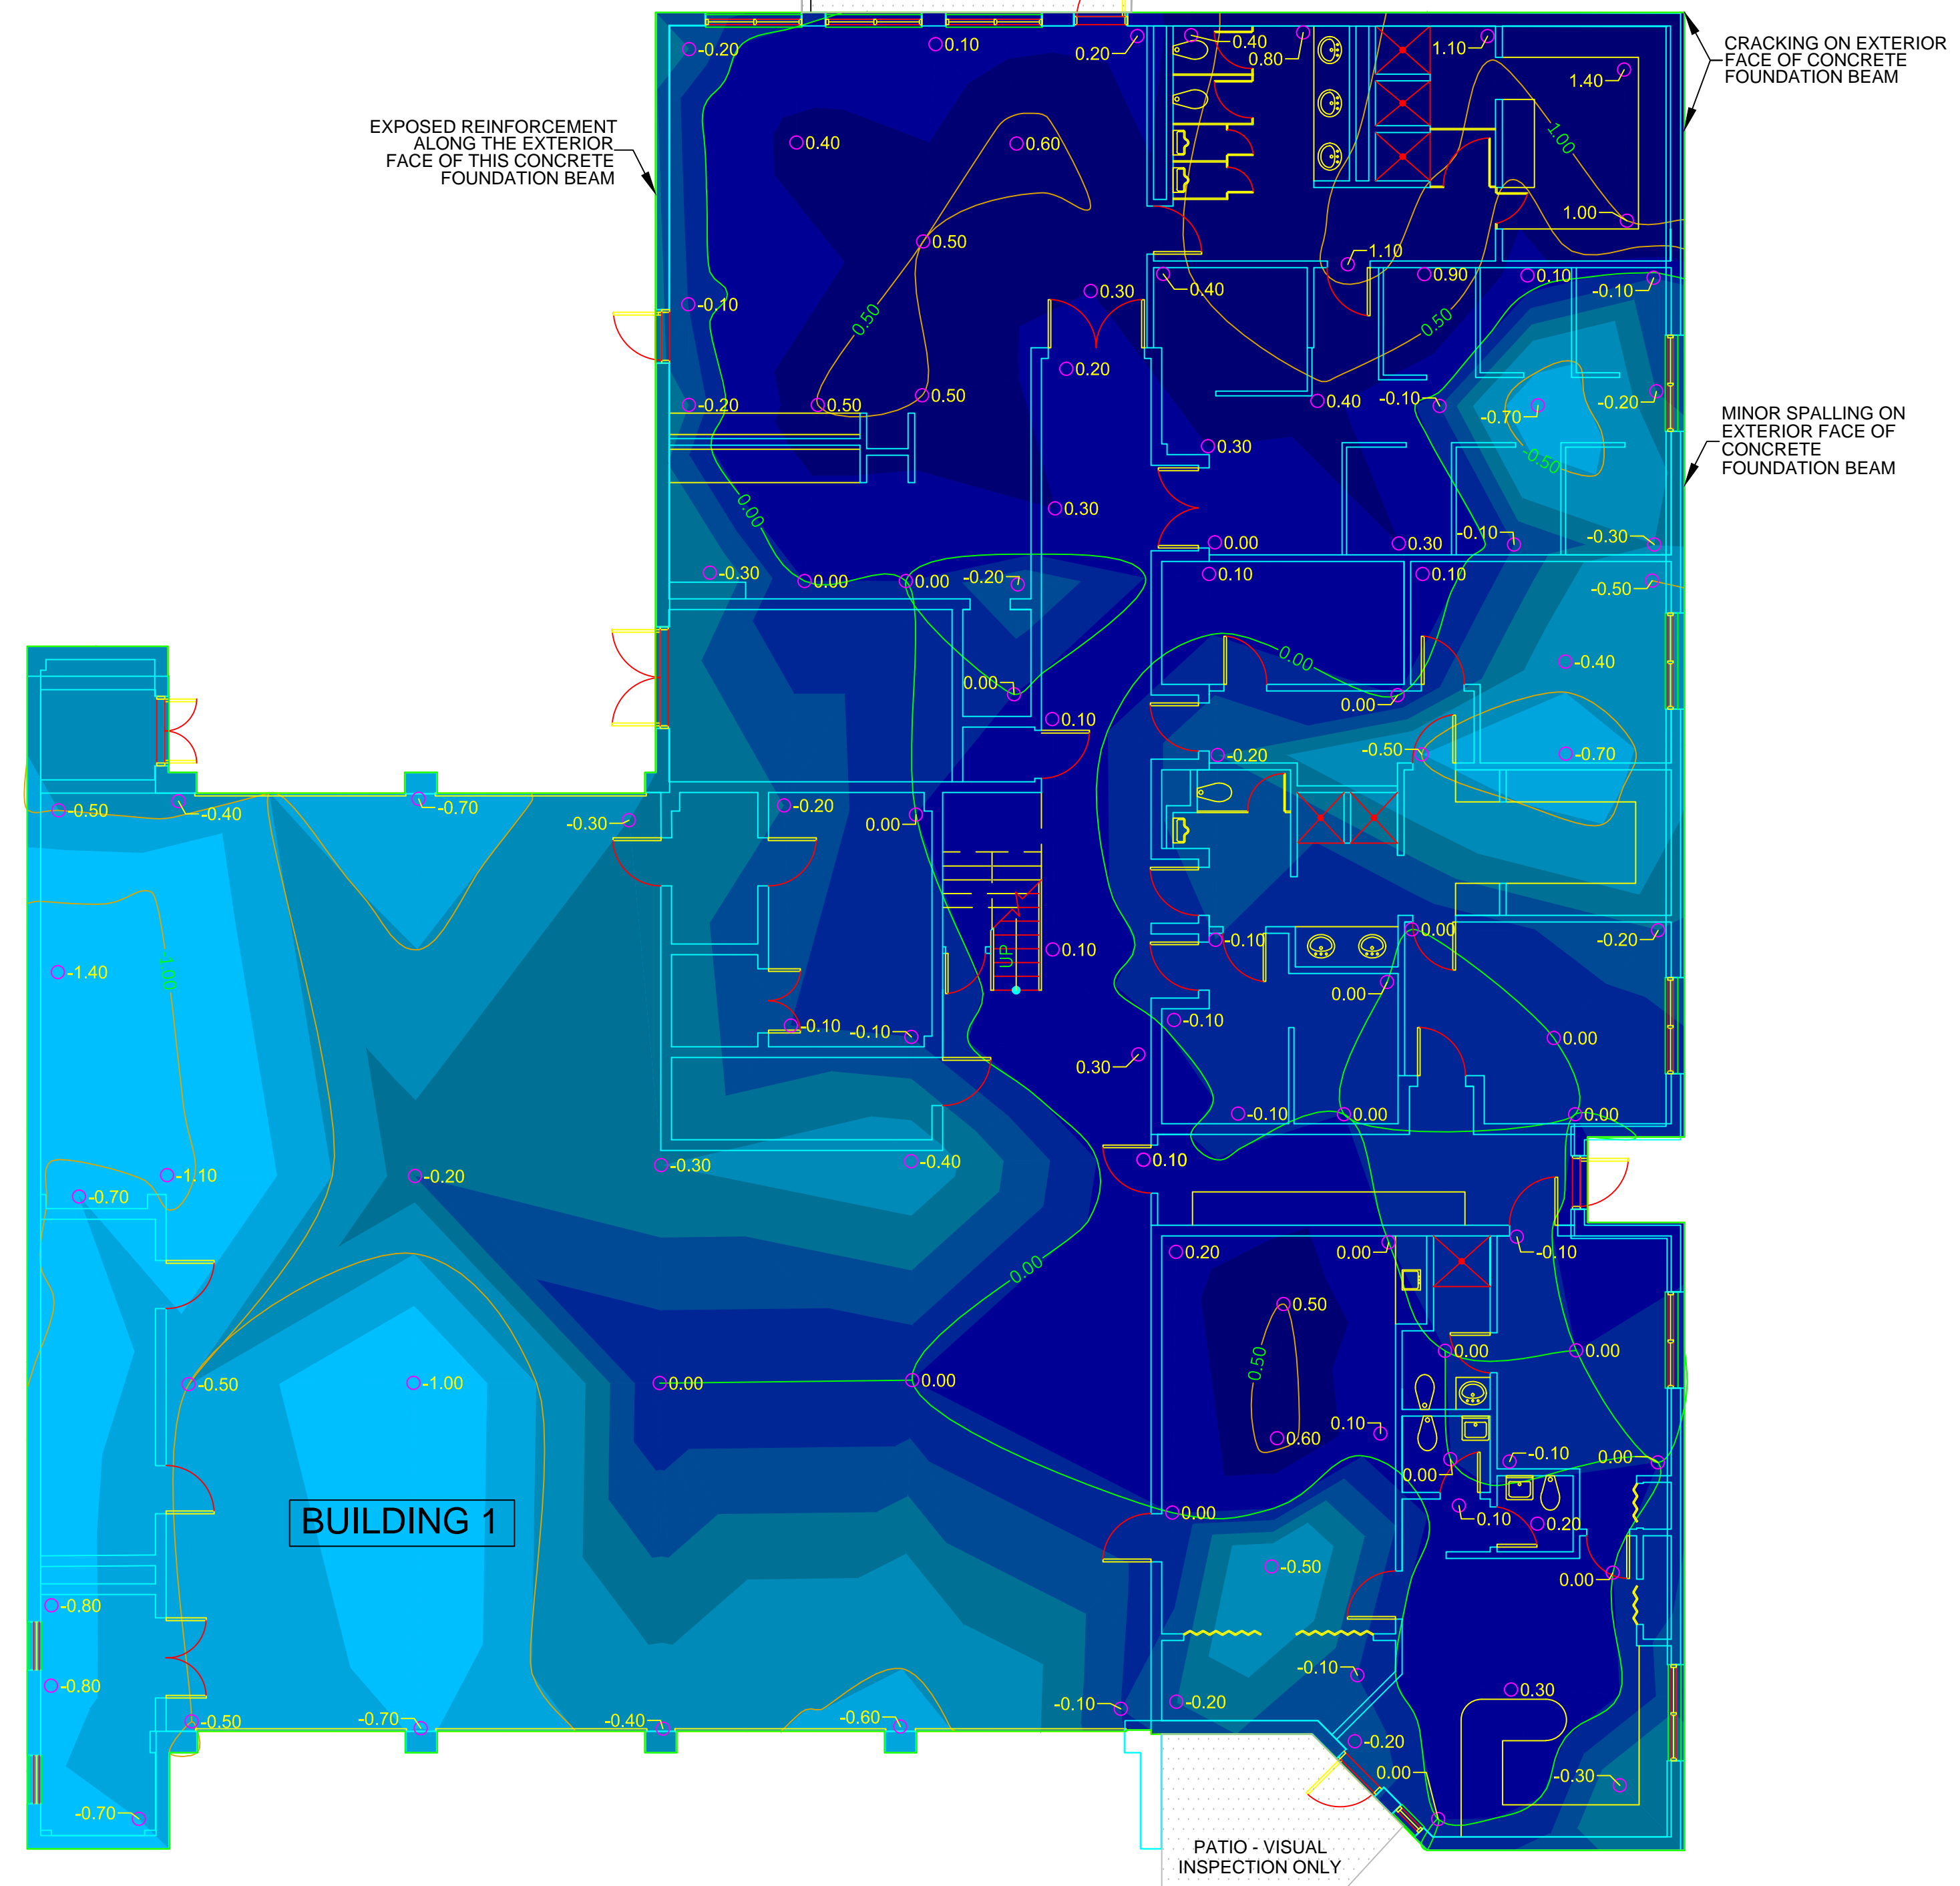
FIGURE 1 - FOUNDATION ELEVATIONS
1/8" = 1'-0"

The foundation of the existing building is believed to be a slab-on-grade supported on under-reamed belled piers based on the original construction documents provided by the building owner. Elevations of the foundation system were measured by Gessner Engineering while onsite using a Zip Level Pro-2000 and are provided in Figure 1.

As a commercial structure, levelness of the floor system is subject to slope guidelines established by the Americans with Disabilities Act (ADA) for levelness. This maximum allowable slope is 2% in any direction. Based on the measurements taken by Gessner Engineering, the maximum noted overall slope across the

building is 0.2% (Reference Figure 1), which is within the allowable limits described above. Upon further analysis, the maximum noted deflection of the foundation was approximately 0.9", resulting in a normalized deflection of L/630, where L is the length in inches over which the deflection occurs. According to the International Building Code (IBC), the maximum deflection due to dead and live loads for a floor member is limited to L/240. This standard is intended to limit the deflection of an individual member, and is not directly applicable to the entirety of the foundation. However, the IBC does state in section 1604.3, titled "Serviceability," "Structural systems and members thereof shall be designed to have adequate stiffness to limit deflections." While the above limit of L/240 does not directly correlate by code to limit the deflection of the "structural system", which in this case is the foundation system, Gessner Engineering believes the intent of the code is to ensure a serviceable structural system. Gessner Engineering, thus, believes the limit of L/240 provides a reasonable limit to the deflection of the overall foundation system to provide the code desired serviceability state, and adopts this limit for the evaluation of commercial foundations. With this understanding, the maximum noted foundation system deflection of L/630 is within the adopted limit of L/240. Therefore, based on the elevations shown on Figure 1 and the limited signs of distress in the structural elements, foundation remediation is not required at this time.

To help improve and maintain the foundation's performance, Gessner Engineering does recommend drainage remediation be performed on the east side of the structure, as described in remediation item 1.16 above. Although the measured elevations do not exceed tolerances, from the damage noted in finishes it is evident that this foundation flexes and the building will require continued maintenance as finishes reflect this seasonal movement. The drainage remediation recommended here is intended to reduce the frequency and magnitude of movement and subsequent need for repairs

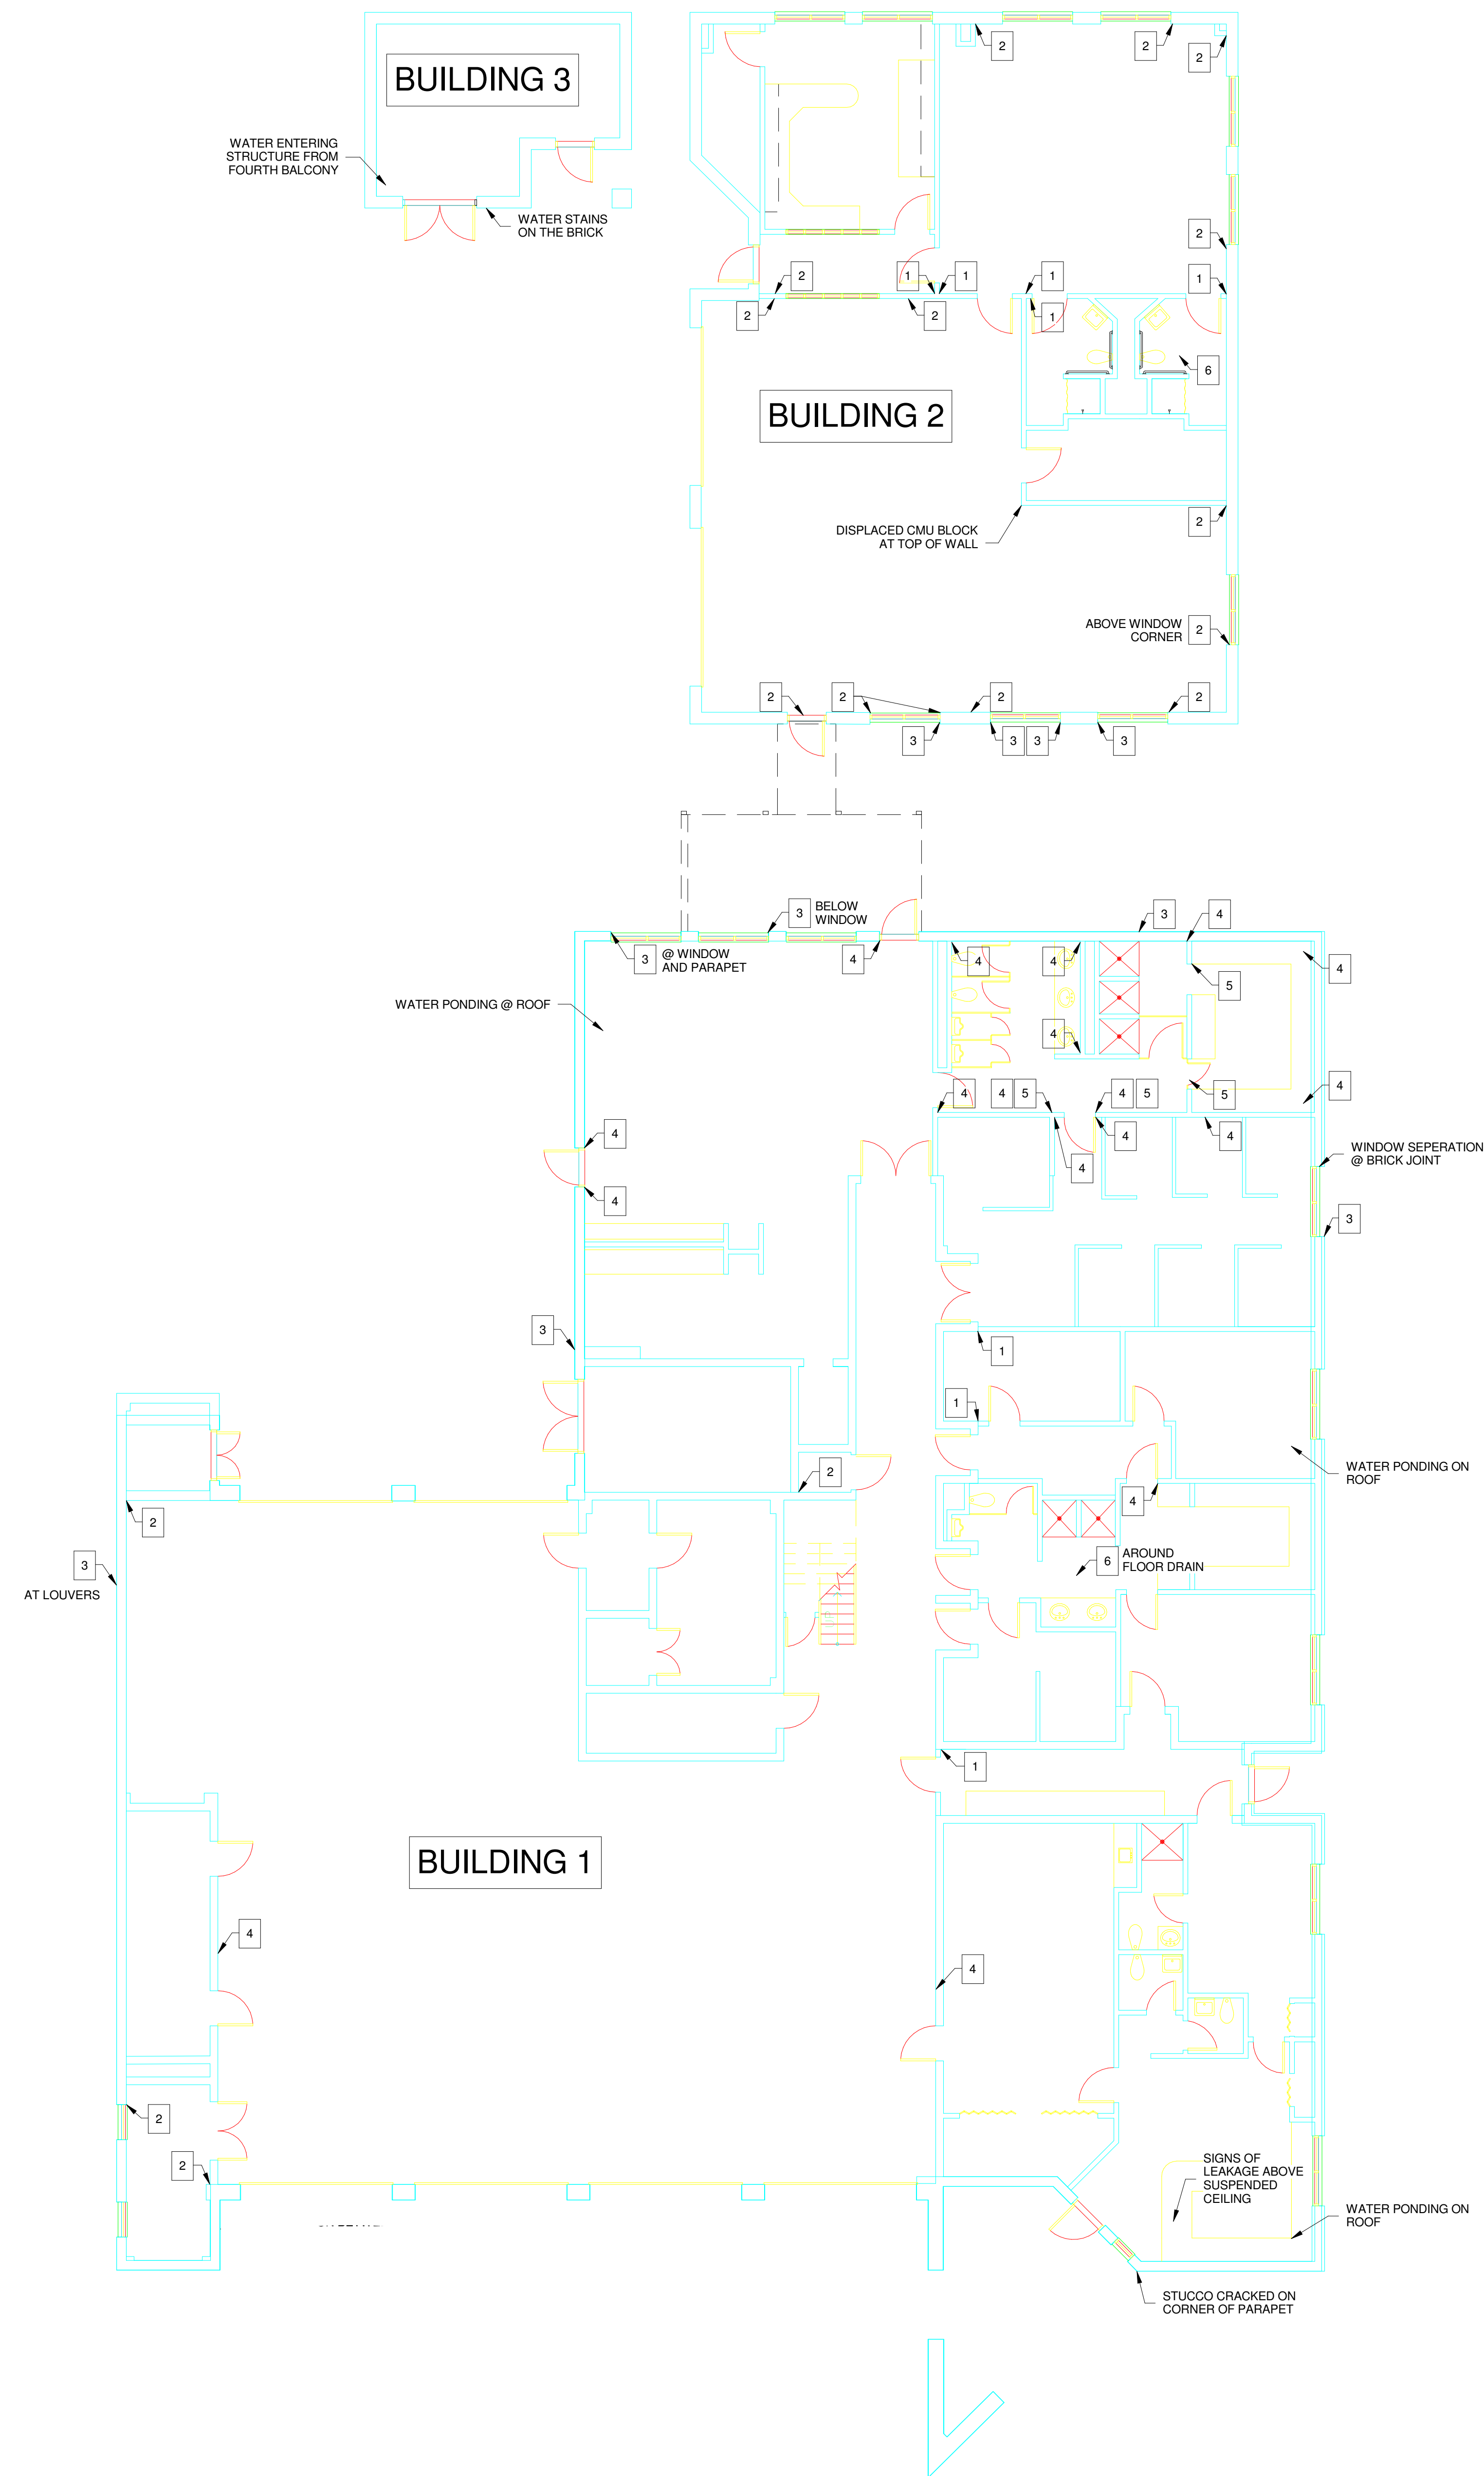
① FIGURE 2 - DEFECTS NOTED IN FRAMING AND FINISHES
1/8" = 1'-0"

- 1.1 Separation between CMU and adjoining light gauge wall
- 1.2 CMU and/or CMU grout cracking
- 1.3 Brick and/or mortar cracking
- 1.4 Sheetrock cracking and/or separation at sheetrock panel joints

- 1.5 Ceiling sheetrock cracking
- 1.6 Tile cracking and/or buckling
- 1.7 Window separation at the north most window on the east side of the building
- 1.8 Signs of leakage above the suspended ceiling in the administrator's office at the front of the building

- 1.9 Signs of leakage at multiple window locations around the building
- 1.10 Stucco cracking at the east corner of the entry parapet
- 1.11 Water ponding along the east side and at the northwest corner of the roof, and clogged primary and secondary roof drains on the east and west sides of the lower roof

- 1.12 Cracking on exterior face of concrete foundation beam
- 1.13 Minor spalling on exterior face of concrete foundation beam
- 1.14 Exposed reinforcement on exterior face of concrete foundation beam

- 1.15 Shrinkage and movement cracking throughout the apparatus bay slab
- 1.16 Poor site drainage on the east side of the building

- 2.1 Separation between CMU and adjoining light gauge wall
- 2.2 CMU and/or CMU grout cracking
- 2.3 Brick and/or mortar cracking
- 2.4 Tile cracking and/or buckling
- 2.5 In the secondary apparatus bay there is a displaced CMU block at the top of the wall on the southwest corner of the storage room where the steel ridge beam penetrates the wall
- 2.6 Slab cracking throughout the secondary apparatus bay
- 2.7 Poor site drainage on the north and east sides of the building
- 2.8 Weep holes below top of existing soil along north side of building

- 1.1 Separation between the two wall types shall be sealed, patched, and re-finished. It should be noted that continued maintenance may be required as the brittle finishes reflect foundation movement.

- 1.2 CMU and/or CMU grout cracking shall be sealed with exterior grade sealant where exposed to weather to avoid possible moisture infiltration into the block.

- 1.3 Brick and/or mortar cracking located at the perimeter of the structure shall be sealed with exterior grade sealant to avoid possible moisture infiltration into the cavity between the brick and the light gauge stud wall.

- 1.4 Sheetrock damage in the walls shall be patched and re-finished. It should be noted that continued maintenance may be required as the brittle finishes reflect foundation movement.

- 1.5 Sheetrock cracking in the ceiling shall be patched and re-finished. It should be noted that continued maintenance may be required as the brittle finishes reflect foundation movement.

- 1.6 Where tile damage is present, Gessner Engineering recommends the tile be removed and replaced over an appropriate cleavage membrane installed between the mortar bed and the foundation. The cleavage membrane will help to minimize the reflection of foundation movement through the tile. Replacing and regrouting the tile at cracks is a less costly option; however this

- 2.1 Separation between the two wall types shall be sealed, patched, and re-finished. It should be noted that continued maintenance may be required as the brittle finishes reflect foundation movement.

- 2.2 CMU and/or CMU grout cracking shall be sealed with exterior grade sealant where exposed to weather to avoid possible moisture infiltration into the block.

- 2.3 Brick and/or mortar cracking located at the perimeter of the structure shall be sealed with exterior grade sealant to avoid possible moisture infiltration into the cavity between the brick and the light gauge stud wall.

- 2.4 Where tile damage is present, Gessner Engineering recommends the tile be removed and replaced over an appropriate cleavage membrane installed between the mortar bed and the foundation. This will minimize the reflection of foundation movement through the tile. Replacing and regrouting the tile at cracks is a less costly option; however this remediation does not improve the current condition and continued cracking is likely. The use of a membrane below the full tiled area will reduce the amount of cracking that is anticipated.

- 2.5 The displaced CMU block shall be removed and grouted in place to prevent a complete detachment and potential falling of the block
- 2.6 Where cracking is present in exposed concrete and conditions allow it, straight joints shall be cut into the slab. Joints and cracks shall be sealed with a traffic grade sealant. It should be noted that continued maintenance may be required as the exposed concrete will reflect foundation movement.
