AUGUST 27, 2015

VILLAGE FIRE DEPARTMENT FIRE STATION No. 1

FEASIBILITY STUDY

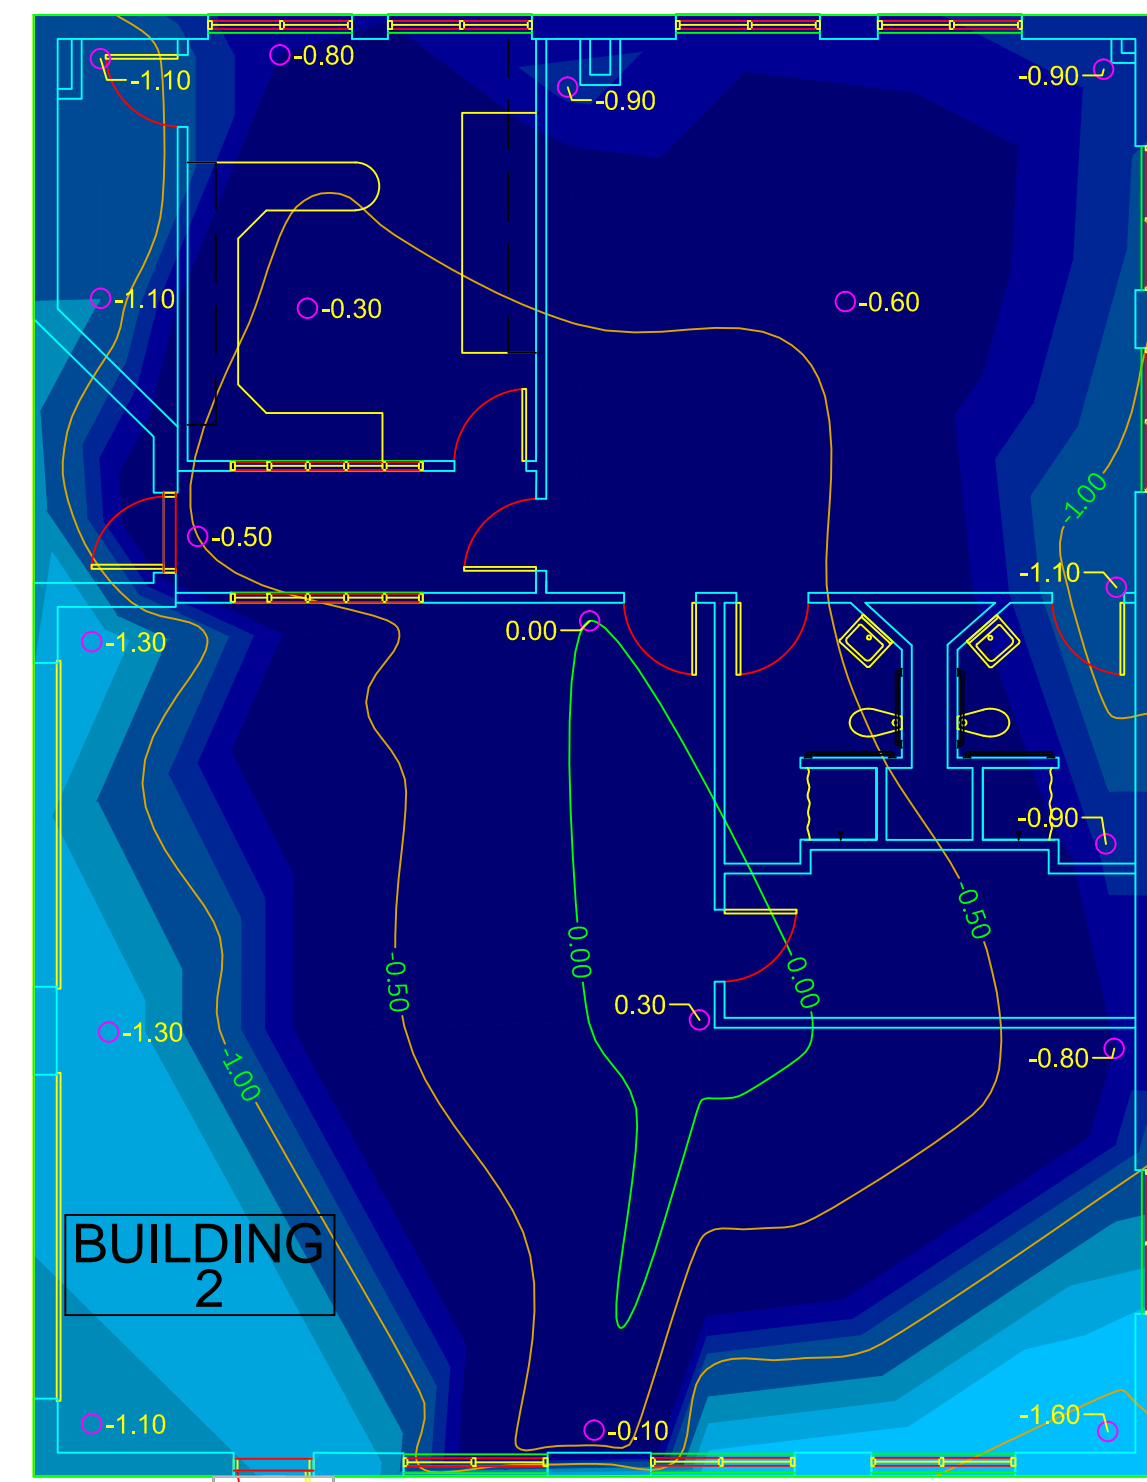
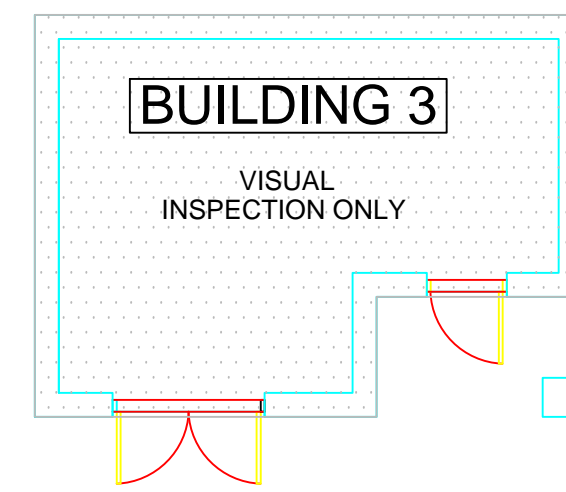
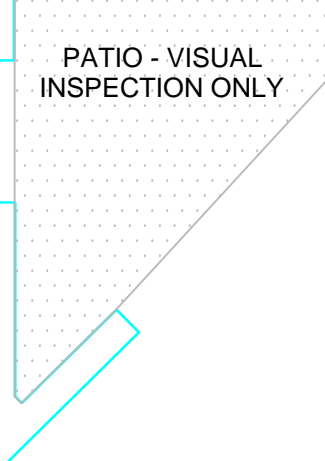
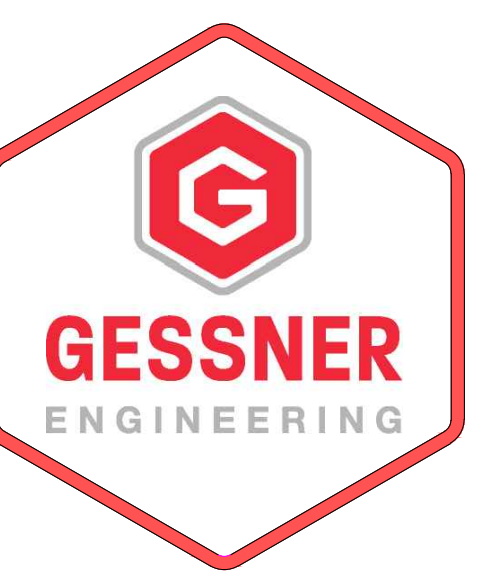
FIGURE 1 - FOUNDATION ELEVATIONS

The foundation of the existing building is believed to be a slab-on-grade supported on under-reamed belled piers based on the original construction documents provided by the building owner. Elevations of the foundation system were measured by Gessner Engineering while onsite using a Zip Level Pro-2000 and are provided in Figure 1.

building is 0.2% (Reference Figure 1), which is within the allowable limits described above. Upon further analysis, the maximum noted deflection of the foundation was approximately 0.9", resulting in a normalized deflection of L/630, where L is the length in inches over which the deflection occurs. According to the International Building Code (IBC), the maximum deflection due to dead and live loads for a floor member is limited to L/240. This standard is intended to limit the deflection of an individual member, and is not directly applicable to the entirety of the foundation. However, the IBC does state in section 1604.3, titled "Serviceability," "Structural systems and members thereof shall be designed to have adequate stiffness to limit deflections." While the above limit of L/240 does not directly correlate by code to limit the deflection of the "structural system", which in this case is the foundation system, Gessner Engineering believes the intent of the code is to ensure a serviceable structural system. Gessner Engineering, thus, believes the limit of L/240 provides a reasonable limit to the deflection of the overall foundation system to provide the code desired serviceability state, and adopts this limit for the evaluation of commercial foundations. With this understanding, the maximum noted foundation system deflection of L/630 is within the adopted limit of L/240. Therefore, based on the elevations shown on Figure 1 and the limited signs of distress in the structural elements, foundation remediation is not required at this time.

The foundation of the existing foundation is believed to be a slab-on-grade supported on under-reamed belled piers based on the original construction documents dated January 21, 2000, provided by the client. Elevations of the foundation system were measured by Gessner Engineering while onsite using a Zip-Level Pro-2000 and are provided in Figure 1.

Based on the measurements taken by Gessner Engineering, the maximum noted overall slope across the building is 0.1%, and the maximum noted deflection of the foundation is approximately 1.3", resulting in a normalized deflection of $L/380$, where L is the length in inches over which the deflection occurs (Reference Figure 1). Per the American with Disabilities Act (ADA) and International Building Code (IBC) standards mentioned previously, the foundation is performing within the allowable limits and does not require foundation remediation at this time.
